Addendum No. 2
City of Coquitlam
Tender No. 81364
Culvert CIPP Installation – Mundy Creek at Cape Horn Ave
(Consists of 12 Pages)
Issue Date: March 17, 2026

Appendix H - Culvert CCTV Inspection Report

Surveyor Name	TREVOR S	Certificate Number	U-0121-70400907
Owner		Customer	CITY OF COQUITLAM
Drainage Area		PO Number	30-6029
Pipe Segment Reference	STCV07998	Date	9/23/2025 13:04
Street	MAGELLAN CRT	City	COQUITLAM
Comments

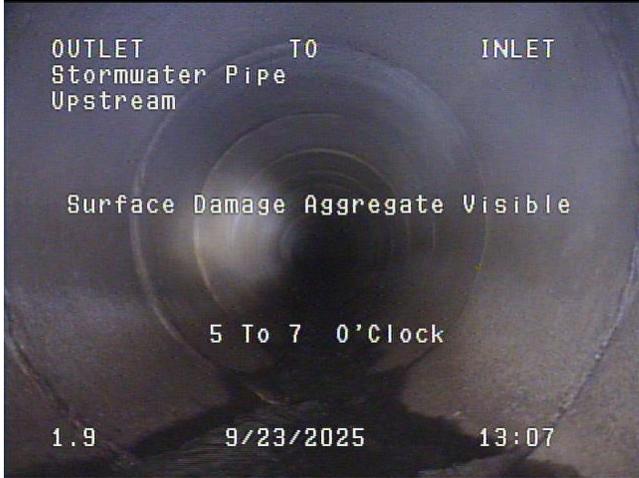
Distance	Fault Observation	Time	Picture
1.9	Surface Damage Aggregate Visible Position: 5 To 7 Severity: None Cont Defect: S01 Attention Required Struct Weight: 2	00:01:15 00:01:15

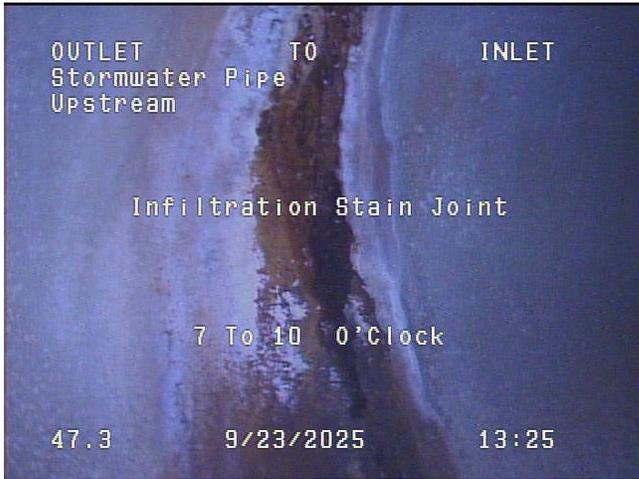
47.3	Infiltration Stain Joint Position: 7 To 10 Severity: None Joint Attention Required Maint Weight: 1	00:06:44 00:06:44

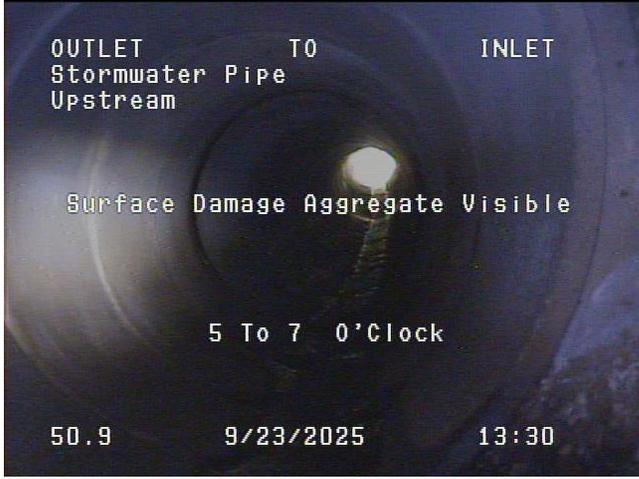
50.9	Surface Damage Aggregate Visible Position: 5 To 7 Severity: None Cont Defect: F01 Attention Required Struct Weight: 2	00:12:15 00:12:15

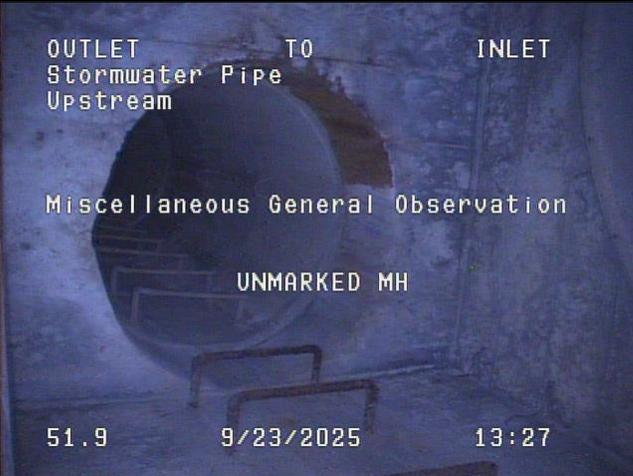
Distance	Fault Observation	Time	Picture
51.9	Miscellaneous General Observation Severity: None Attention Required Remarks: UNMARKED MH	00:08:33 00:08:33

<p>OUTLET TO INLET Stormwater Pipe Upstream</p> <p>Miscellaneous General Observation</p> <p>UNMARKED MH</p> <p>51.9 9/23/2025 13:27</p>
51.9	Miscellaneous Abandoned Survey Severity: None Attention Required Remarks: DUE TOO DROP IN MH MAY ATTEMPT REVERSAL	00:10:59 00:10:59

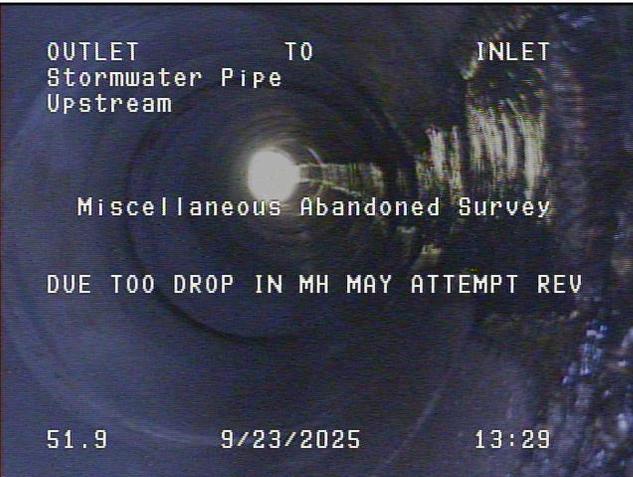
<p>OUTLET TO INLET Stormwater Pipe Upstream</p> <p>Miscellaneous Abandoned Survey</p> <p>DUE TOO DROP IN MH MAY ATTEMPT REV</p> <p>51.9 9/23/2025 13:29</p>
