# Pre-Renovation Limited Hazardous Materials Inspection Report

**Eagle Ridge Outdoor Pool**  
**2689 Guildford Way, Coquitlam, BC**

**CITY OF COQUITLAM**

Inspection Date: Mar/12/2026

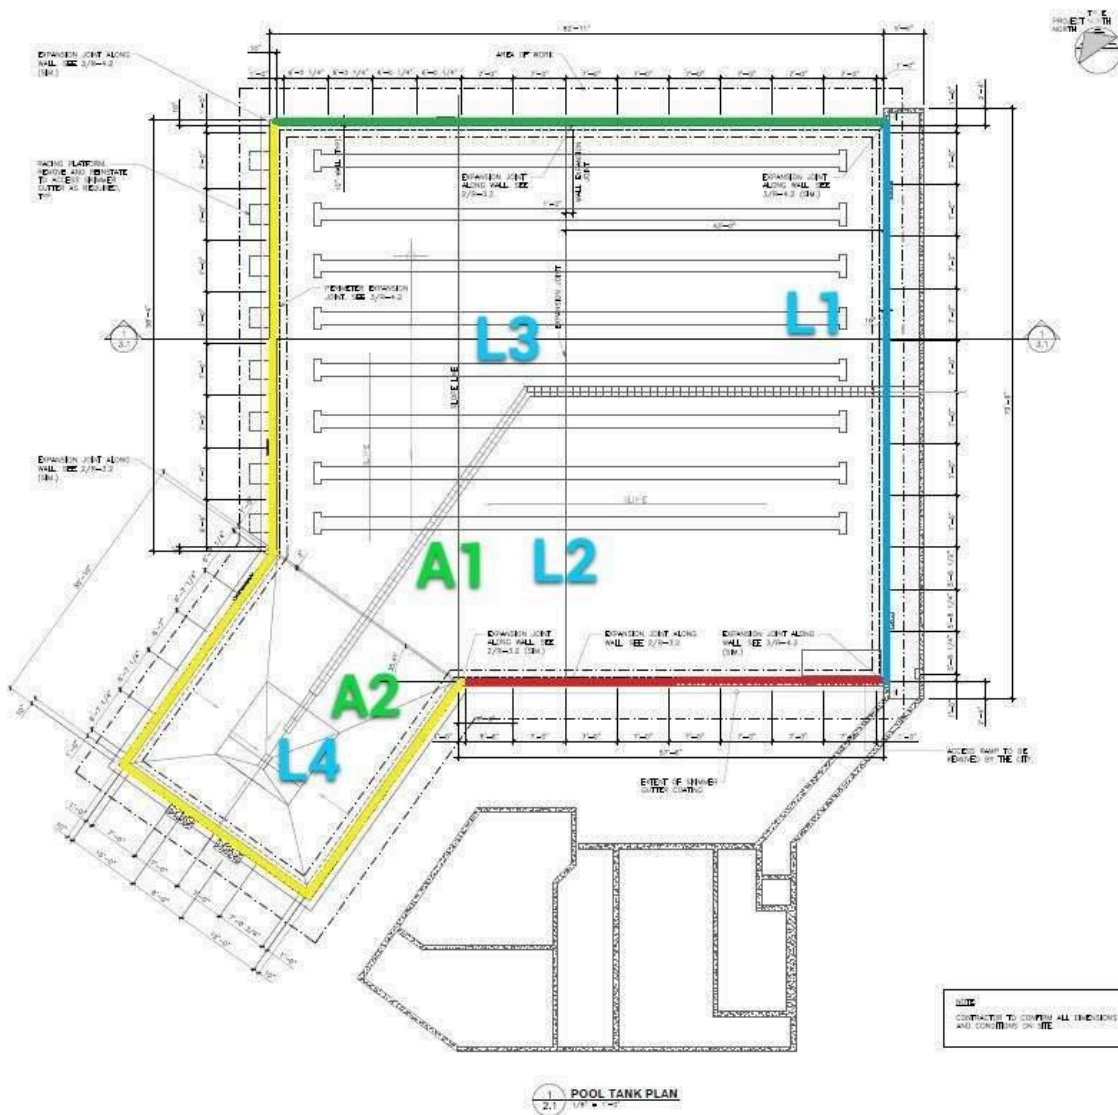
### Sample locations - Pool Basin

Samples were collected from areas where renovation work is scheduled to take place. Specific sample locations and descriptions can be found in the laboratory report under the Location and Description section.
